Protrk's was contracted to replace an existing asphalt ADA stall and noncompliant sloped concrete access aisle. Considering the existing overall drainage pattern against the curb, Protrk's experience came to bear in the solution. Our team sloped the parking stall up to meet existing compliant grades at the curb level and installed a trench drain to provide a smooth compliant transition. Our solution spared out client the loss of an additional parking stall and reduced the amount of concrete walk to be torn out and replaced. From demolition to new concrete, this project was substantially completed in two days.

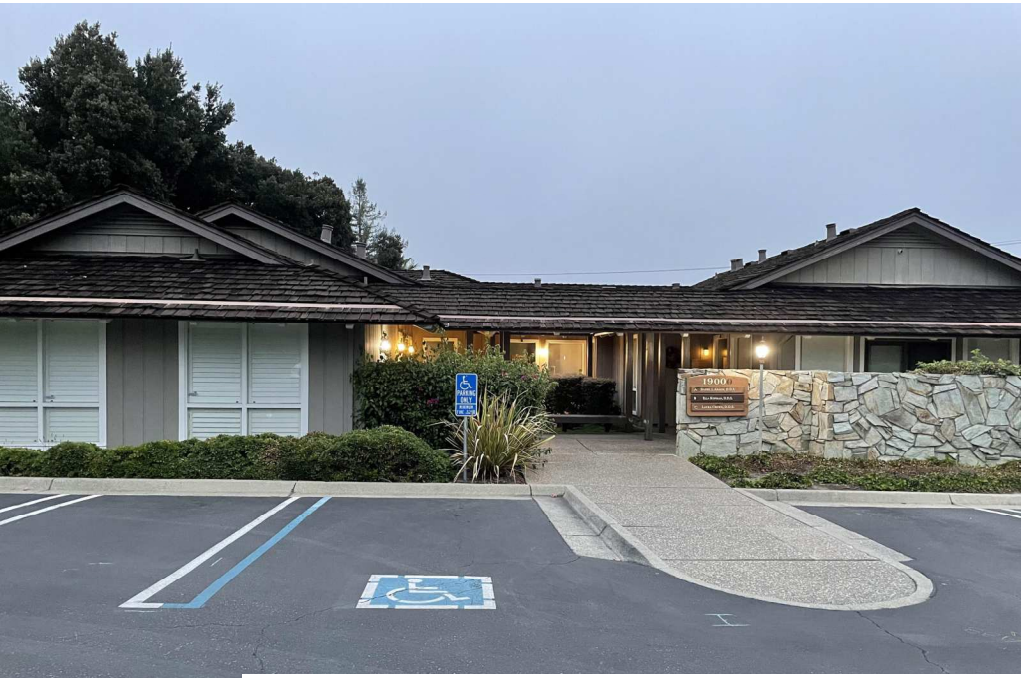
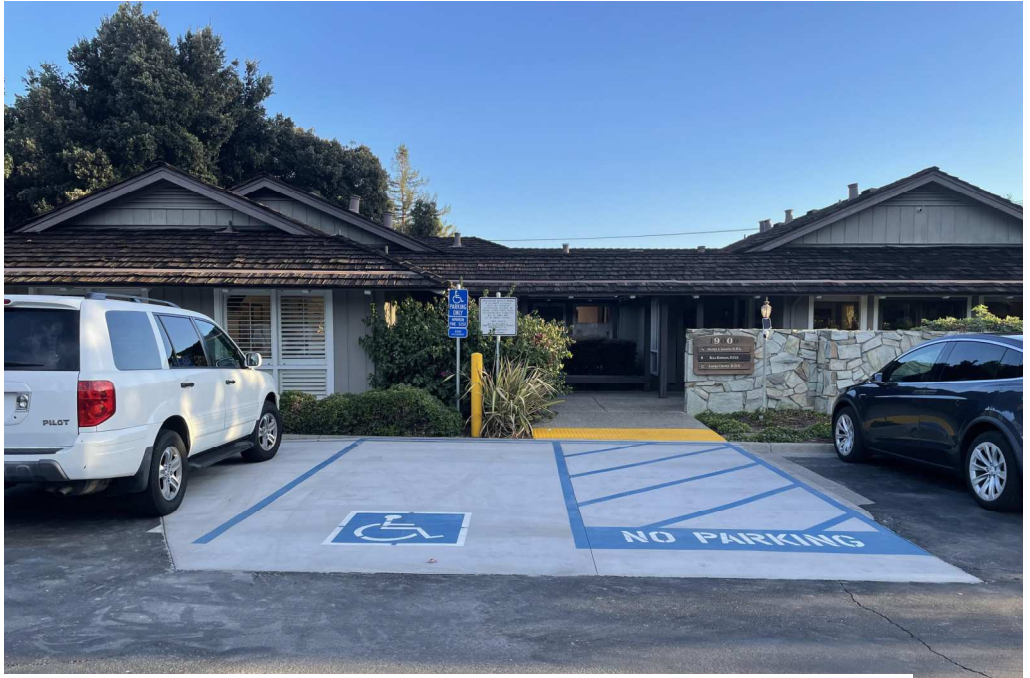
The existing non-compliant parking stall also included a sloped walk in lieu of an ADA compliant level access aisle and curb ramp. The primary site drainage sloped toward the existing curb and under the current raised sidewalk through a pipe. Protrk mitigated non-compliant slopes by installing the new concrete parking stall and access aisle level with the existing curb. Installing a trench drain allows for ease of maintenance as well as an ADA compliant transition from the existing walk to the new parking area.
